AN ANALYSIS OF TRAFFIC ACCIDENT RATES ON THE UJUNG TANJUNG–BAGAN SIAPI API ROAD SECTION (KM 6–KM 60), ROKAN HILIR REGENCY, RIAU PROVINCE

Abdul Kudus Zaini¹, Rahmad Kurniawan², Vella Anggreana³

Civil Engineering Program, Faculty of Engineering Islamic University of Riau, Indonesia

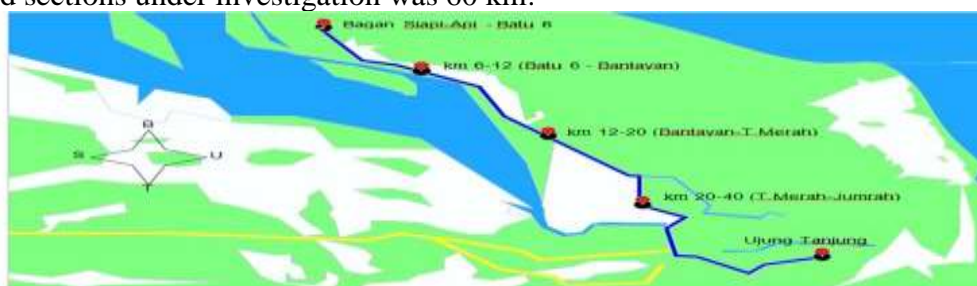
Figure 1. Research Location

This study focused on the following road sections: the Bagansiapi-api–Batu 6 section (6 km), the Batu 6–Bantayan section (6 km), the Bantayan–Tanah Merah section (8 km), the Tanah Merah–Jumrah section (20 km), and the Jumrah–Ujung Tanjung section (20 km). The total length of the road sections under investigation was 60 km.
